Eglington

Conservation Area Character Appraisal

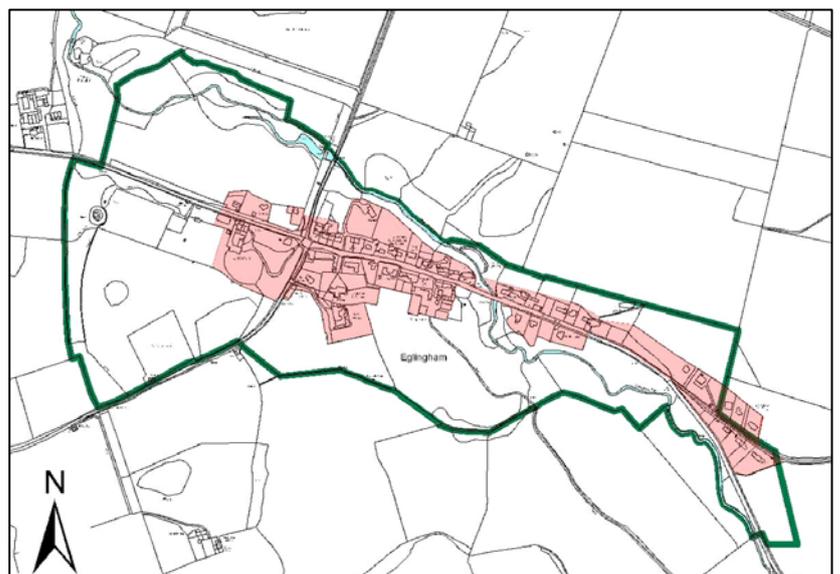
Eglingham Conservation Area - settlement shown pink, boundary of conservation area green.(old boundary)

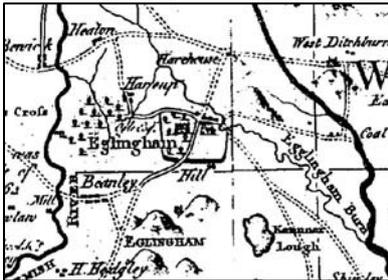
Armstrong's map of 1769 shows the Hall and Church enclosed, houses both sides of the road between the Church and Mill, and the old road south to Alnwick.

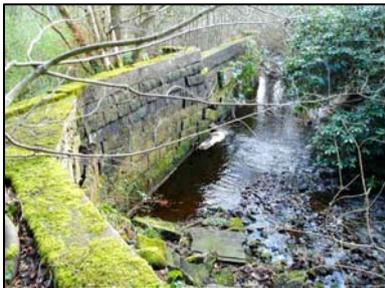
The millpond - Tarry Road

The road past the millpond led to the Tarry Colliery on the moor to the north, and is now well used for recreation. The colliery was in production by the 18th century, and possibly earlier, as remains of iron smelting has been found on the moors. However mining has never been as important here as in some parts of Northumberland: in 1861 approximately 15% of the working population of the village were miners, compared to 30% in agriculture and 25% in domestic service. The colliery was closed in 1910.

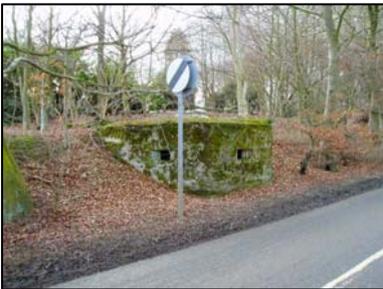
Pillbox - Eglingham Hall

Three pillboxes dating from WW II are sited in the village, important as part of the national Stop-Line defences which locally ran from the coast inland to Wooler and back to the coast via Alnwick.

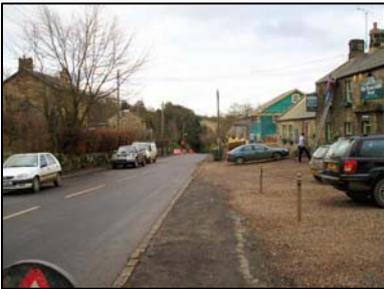
Buildings more dense in the village centre - Tankerville Arms

Building density is highest in the historic centre, between the church and bridge, but even here the impression is one of open linearity with tightly framed views between buildings, of the surrounding hills. The narrow road is given a sense of spaciousness by the setting of the buildings a short distance back from the road, behind low stone retaining walls or raised on grassy banks, increasing the sense of enclosure and directional movement along the street. At the burn, the road narrows suddenly to the bridge, but views open up dramatically to the south.

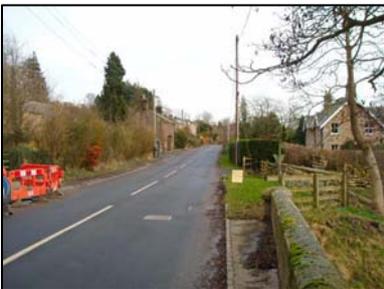
Houses strung along the road - looking east from the bridge

To the east of the bridge, the street is level and the houses more dispersed, with some, such as the old smithy, set well back from the road. A backdrop of trees and larger houses rises to the north with important open

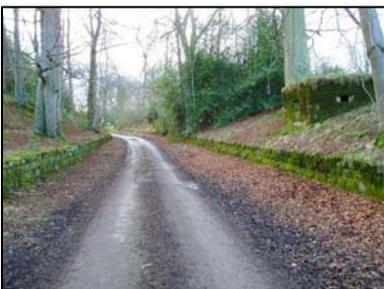
Trees and walls - Tarry Road

Tarry Road, with its tunnel of mature trees, has something of the character of an estate drive, gently curving downhill, lined by retaining walls of high quality masonry, encouraging exploration of the millpond area.

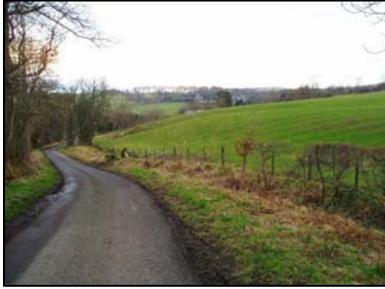
Fences and hedges - Beanley Road

Beanley Road, on the other hand, with agricultural fencing and the remains of hedging, retains the character of a rural lane as it circles round the grounds of Eglingham Hall and meanders up into the countryside beyond.

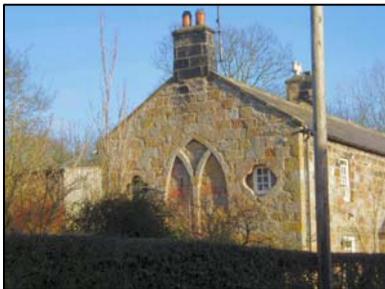
Mill House

The gothic gable end of Mill House, the windows of Delph Lodge and other details on individual houses underline the special character of the village. There is also some interesting metalwork.

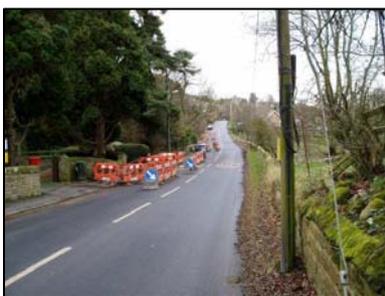
Dense planting at the community centre to N and open view to S - the bridge

As noted in 1 above, the open spaces surrounding the settlement form a major component of the conservation area. The views thus protected are key to the character of the area, and the buildings at times are subservient to the views. This is obvious at the burn; the geographical centre of the village, where uninterrupted open views to the south, contrast with the steep riverbank and dense planting to the north.

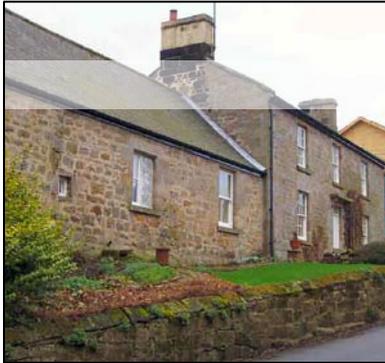
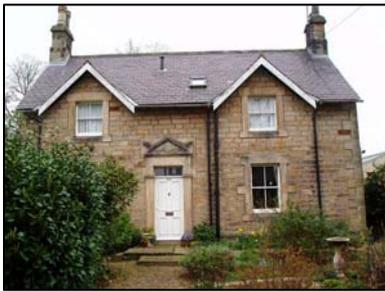
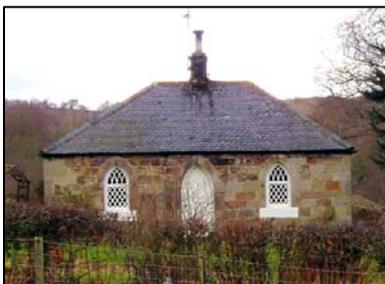
Delph Lodge

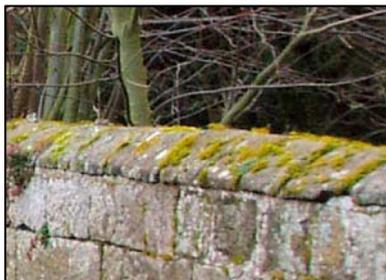
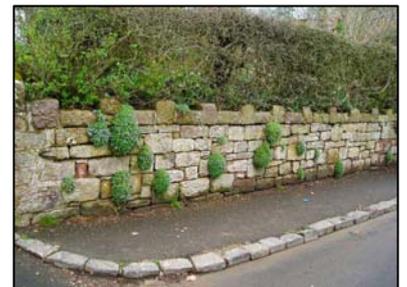
Many of the roadside walls are of good quality masonry with distinctive triangular section or castellated copes. Roadside details such as the mounting block and horse trough opposite the Tankerville Arms and several old style 30mph signs give special interest.

Wall copes – main road and Tarry Road

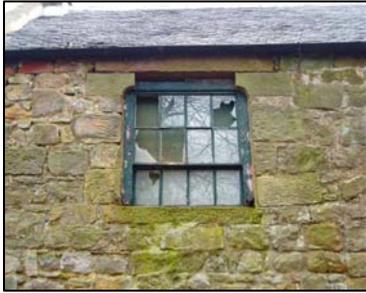
Window head detail

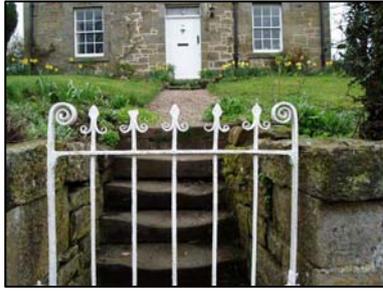
Metal gates – main road

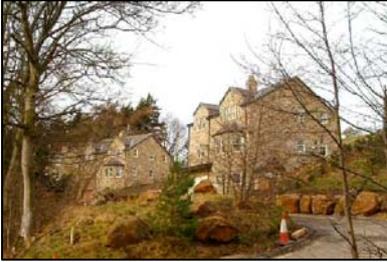
3-storey buildings, raised above road, not on building line - The Terrace

The large new buildings to the west of The Terrace are out of scale and character with the remainder of the conservation area, particularly in their placement on the site. Some of the modern infill houses are also out of character with the area, either in their position on their site, form or details.

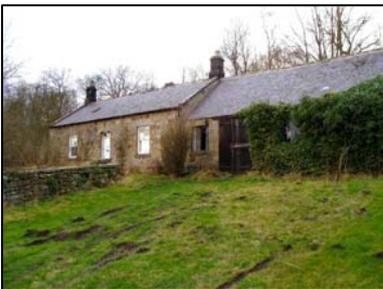
Old Smithy, Ogle Arms - B6346

No buildings in the village appear on the English Heritage Buildings at Risk Register. The Grade II listed Smithy is in poor condition, but undergoing renovation; it retains its forge, and forms an important part of the Ogle Arms complex to the east of the bridge, every effort should be made to encourage its conservation.

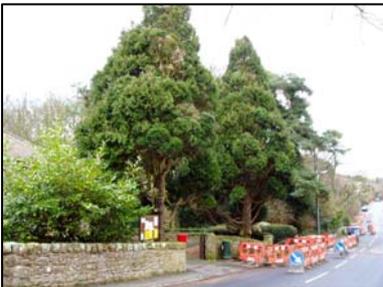
There is little public open space from which to appreciate the conservation area. This is particularly noticeable at the bridge, where it is difficult to stop and enjoy the views and the two large evergreen trees beside the Community Centre obscure the buildings and constrict the open space at this central point of the village.

Community centre and river bank obscured by trees and shrubs - the bridge

If the shrubs at the Community Centre could be removed, and the area re-landscaped, a public area could be created forming a breathing space along the road with

room to sit and enjoy views over the valley to the south, as well as the picturesque river bank to the north.

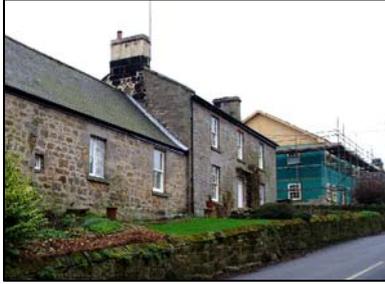
New house respects plan form and building line - B6346

Sympathetic development within the Conservation Area need not be ruled out; the new house being constructed next to the Tankerville Arms at the time of the audit seems to respect the conservation area in terms of siting and materials. As well as infill of this type additions and improvements to the existing building groups mentioned above could be considered, and could for example improve the important view of Village Farm from the bridge.
